# MICROCHIP PIC12(L)F1822/PIC16(L)F1823

## PIC12(L)F1822/PIC16(L)F1823 Family Silicon Errata and Data Sheet Clarification

The PIC12(L)F1822/PIC16(L)F1823 family devices that you have received conform functionally to the current Device Data Sheet (DS41413A), except for the anomalies described in this document.

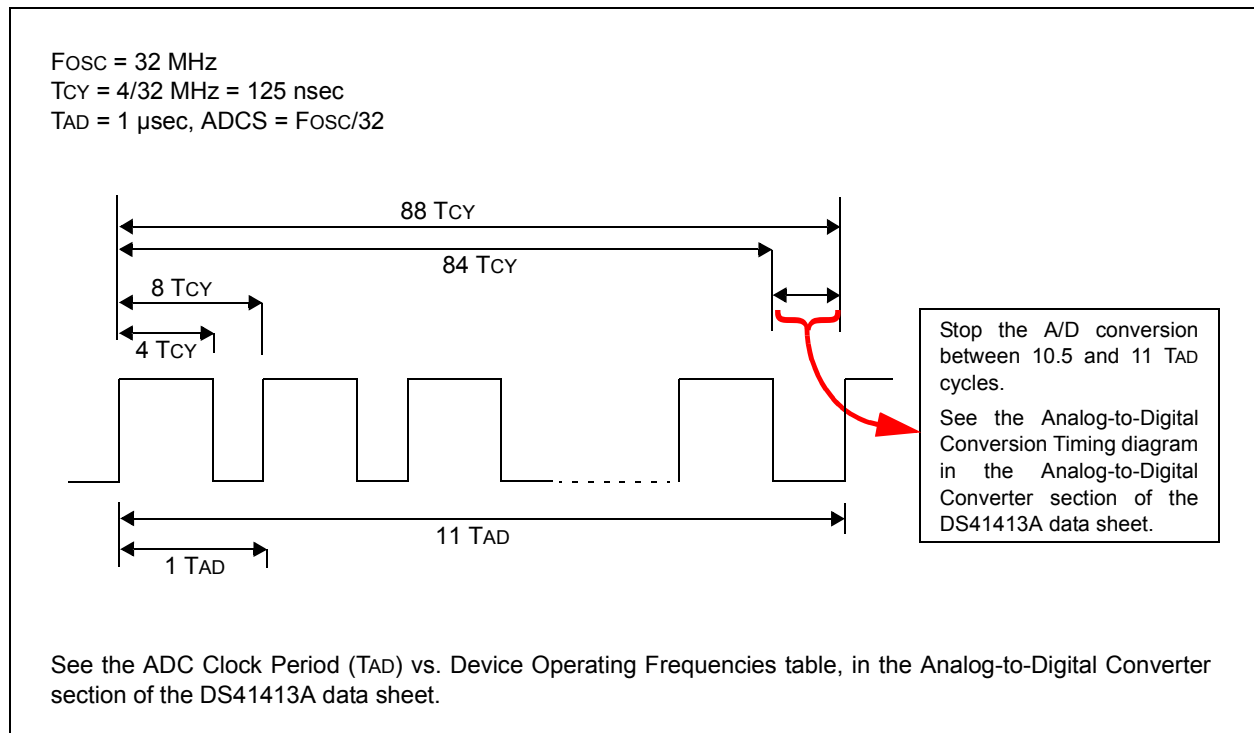
**FIGURE 1: INSTRUCTION CYCLE DELAY CALCULATION EXAMPLE**

Under certain device operating conditions, the ADC conversion may not complete properly. When this occurs, the ADC Interrupt Flag (ADIF) does not get set, the GO/DONE bit does not get cleared and the conversion result does not get loaded into the ADRESH and ADRESL result registers.

In Figure 1, 88 instruction cycles (Tcy) will be required to complete the full conversion. Each TAD cycle consists of 8 Tcy periods. A fixed delay is provided to stop the A/D conversion after 86 instruction cycles and terminate the conversion at the correct time as shown in the figure above.

**Note:** The exact delay time will depend on the choice of Fosc and the TAD divisor (ADCS) selection. The Tcy counts shown in the timing diagram above apply to this example only. Refer to Table 3 for the required delay counts for other configurations.

Method 2: Provide a fixed delay in software to stop the A-to-D conversion manually, after all 10 bits are converted, but before the conversion would complete automatically. The conversion is stopped by clearing the GO/DONE bit in software. The GO/DONE bit must be cleared during the last ½ TAD cycle, before the conversion would have completed automatically. Refer to Figure 1 for details.

## EXAMPLE 1: CODE EXAMPLE OF INSTRUCTION CYCLE DELAY

```
BSF    ADCON0, GO/DONE; Start ADC conversion
                        ; Provide 86
                        ; instruction cycle
                        ; delay here
BCF     ADCON0, GO/DONE; Terminate the
                        ; conversion manually
MOVWF  ADRESH, W      ; Read conversion
                        ; result
```
